Hydrology and Hydraulics

What are the hydraulic and hydrologic implications of the LIFE III Restoration project?

Geomorphology

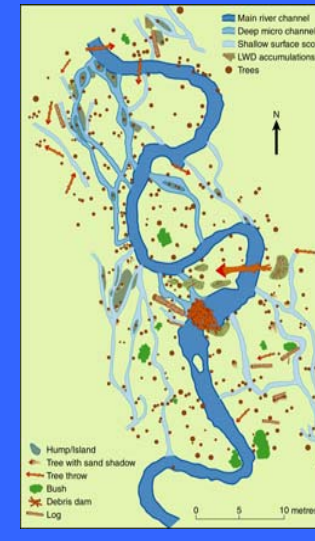
Diverse, with in-channel debris dams flow causing sediment deposition and erosion on the floodplain creating a network of floodplain channels.

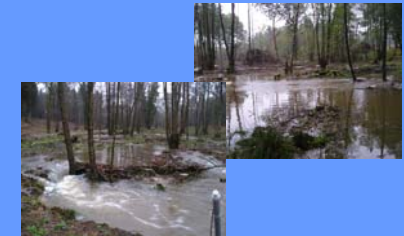
A. Overbank flow due to smaller channel dimensions and debris dams
